our ref. **SAT_046**

Subject: Front door for HR100, HRV120 e HRV120 Style models

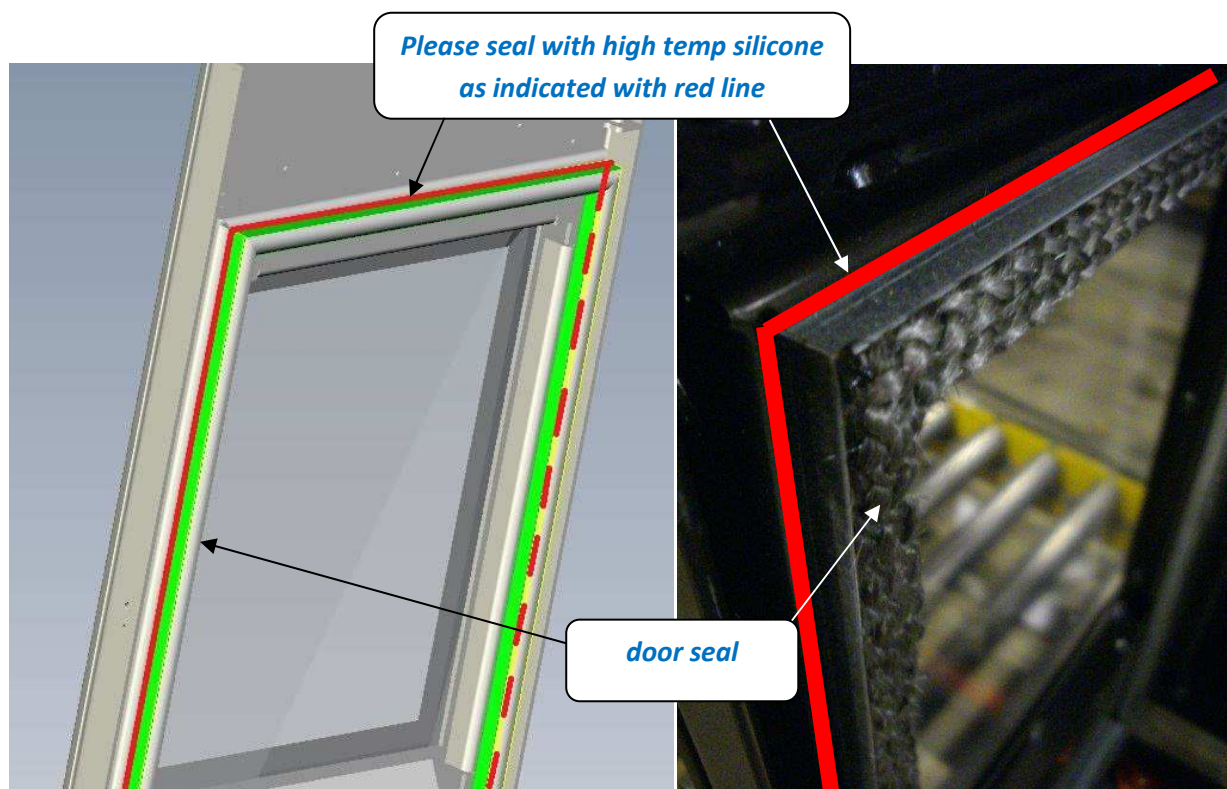
Some front doors of mentioned models could show air infiltration from outside, between the seal support (metal) and the inner part of the front door itself.

This situation can create low flux reading and an irregular combustion, low smoke temperature and choke of the firepot after few working hours.

We therefore suggest to verify the condition of the seal support and in case proceed with a proper sealing with high temp silicone as shown of figures below (a video will be posted soon in our Italian web Home Page - Area Riservata).
